**UMDLOTI APRIL 2022
FLOODS:
CSCM STORM
DISASTER RESPONSE**

UMDLOTI STORM DAMAGE APRIL 2022

COASTAL, STORMWATER &
CATCHMENT MANAGEMENT
DEPARTMENT

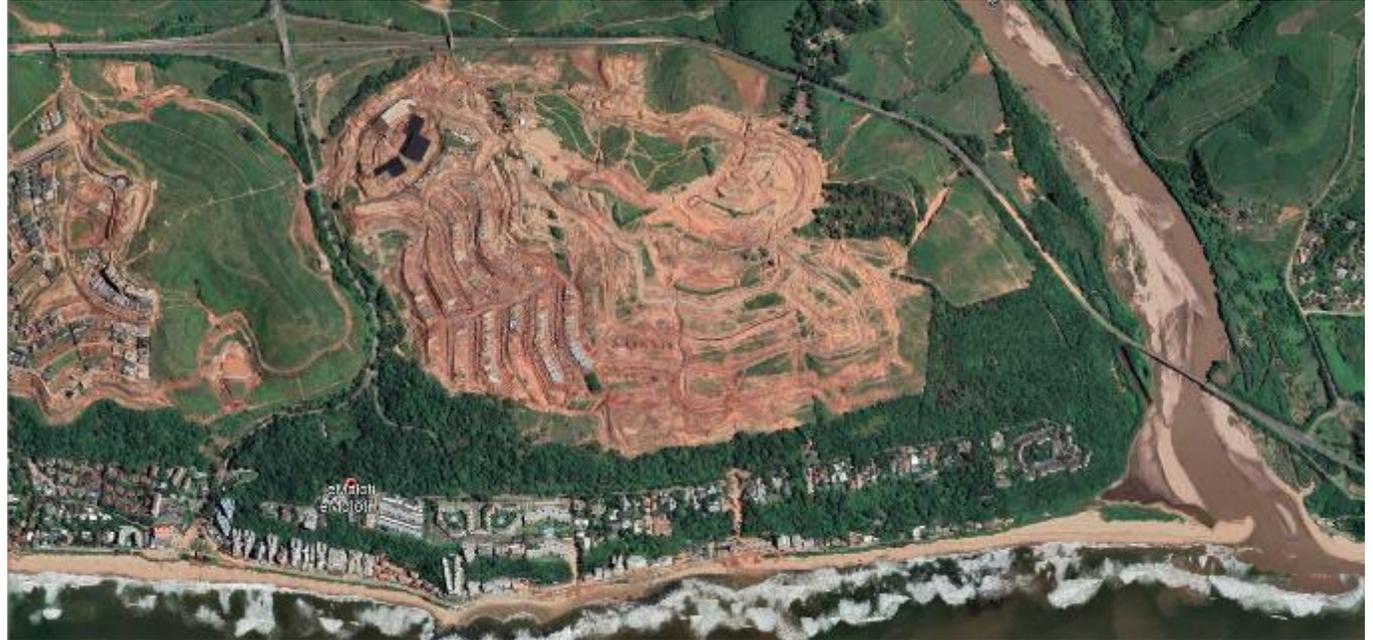
35/36 Bellamont Road

- Scour depth of greater than 50 m.
- 76 300m³ of material was washed away.

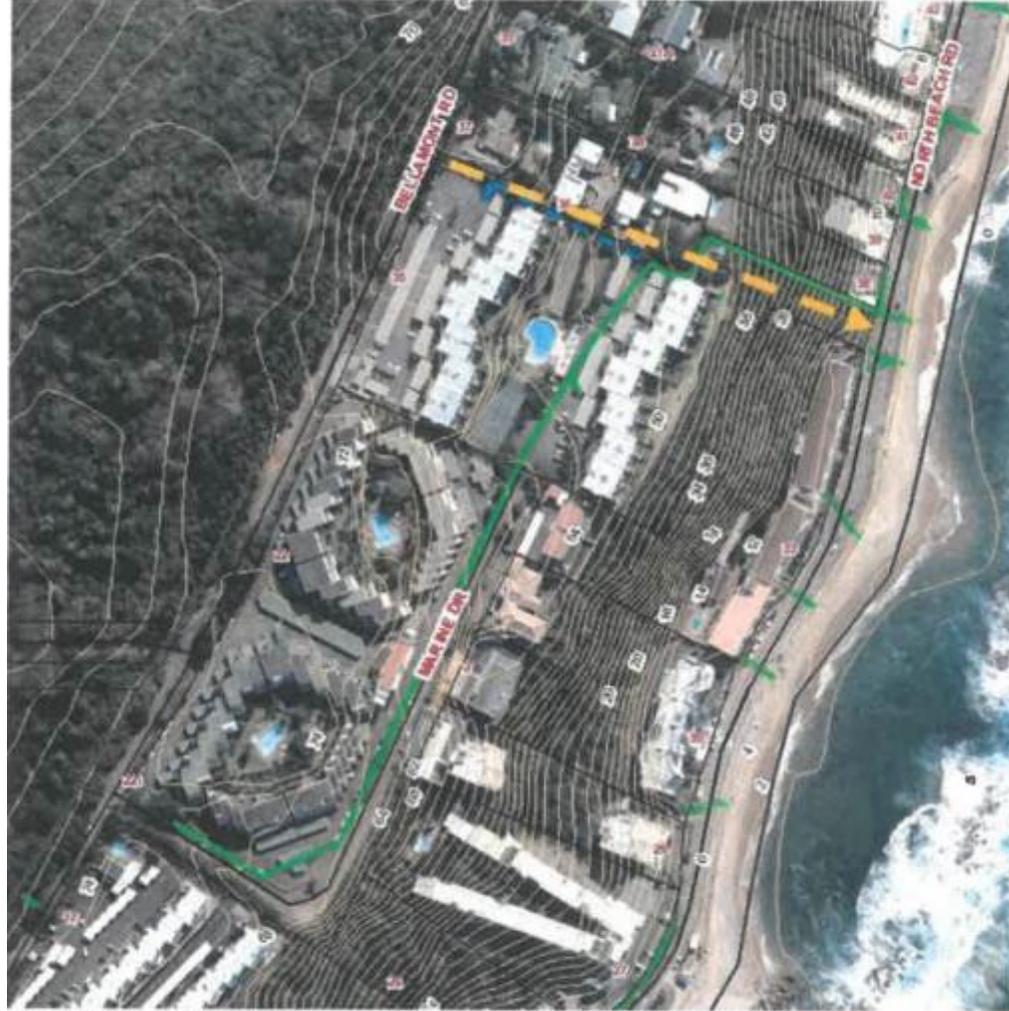
Figure 24 GIS showing records of Council Stormwater at Southern Erosion Line

900mm
concrete
stormwater
pipe from 35
Bellamont
discharging
onto beach.
