**UMDLOTI APRIL 2022
FLOODS:
CSCM STORM
DISASTER RESPONSE**

UMDLOTI STORM DAMAGE APRIL 2022

COASTAL, STORMWATER &
CATCHMENT MANAGEMENT
DEPARTMENT

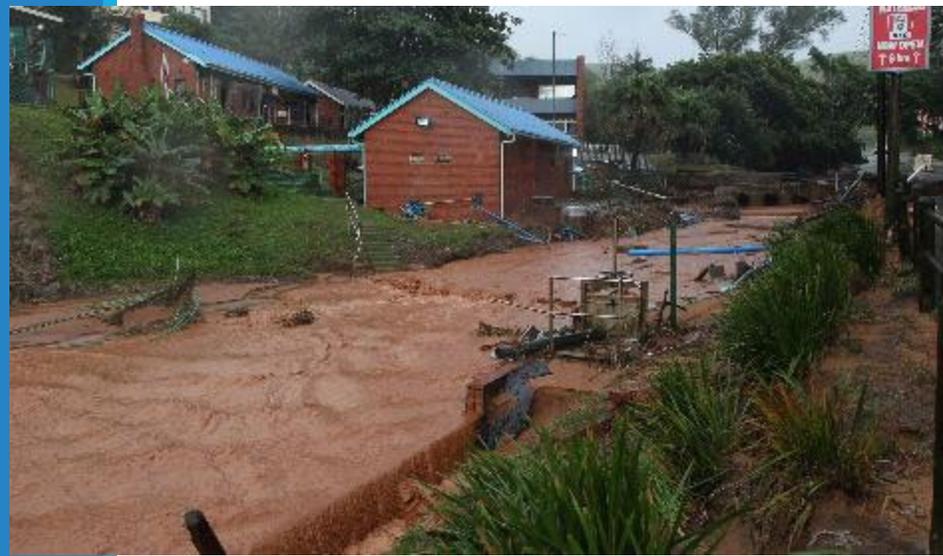
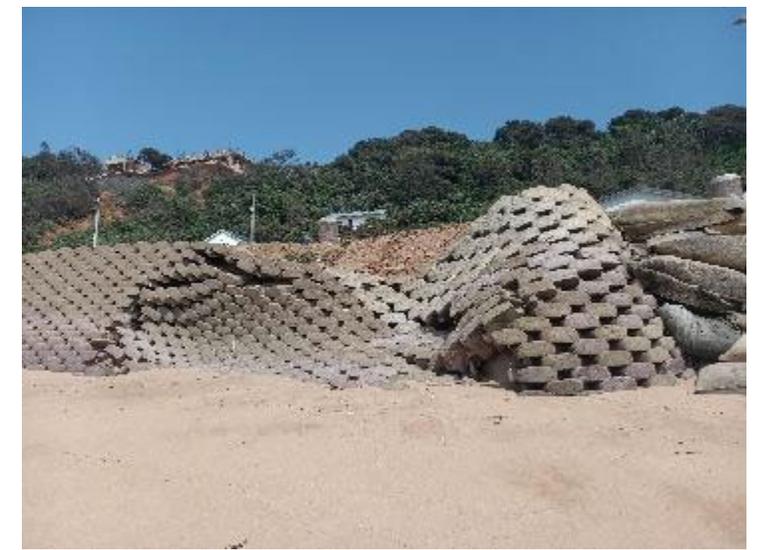
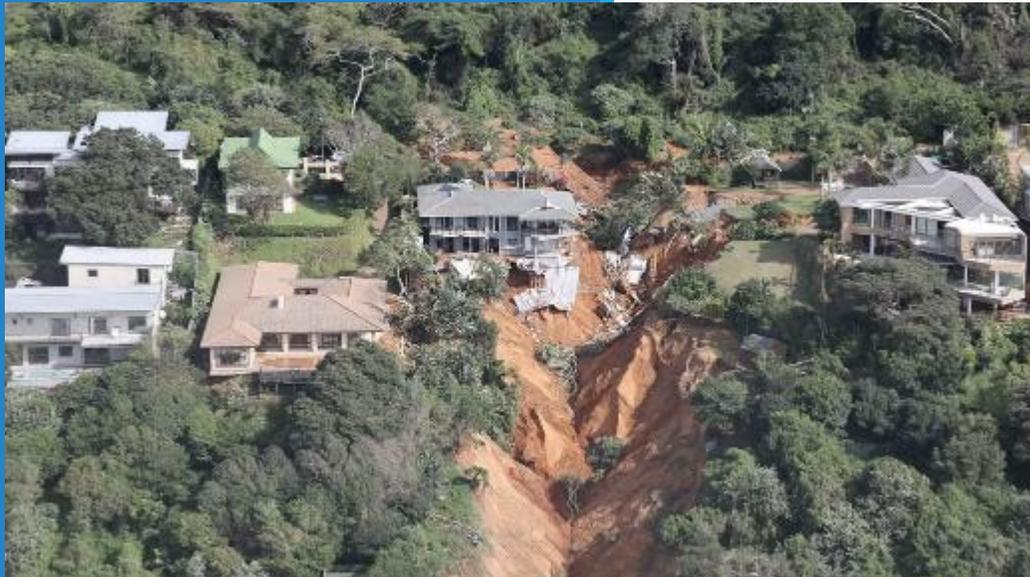
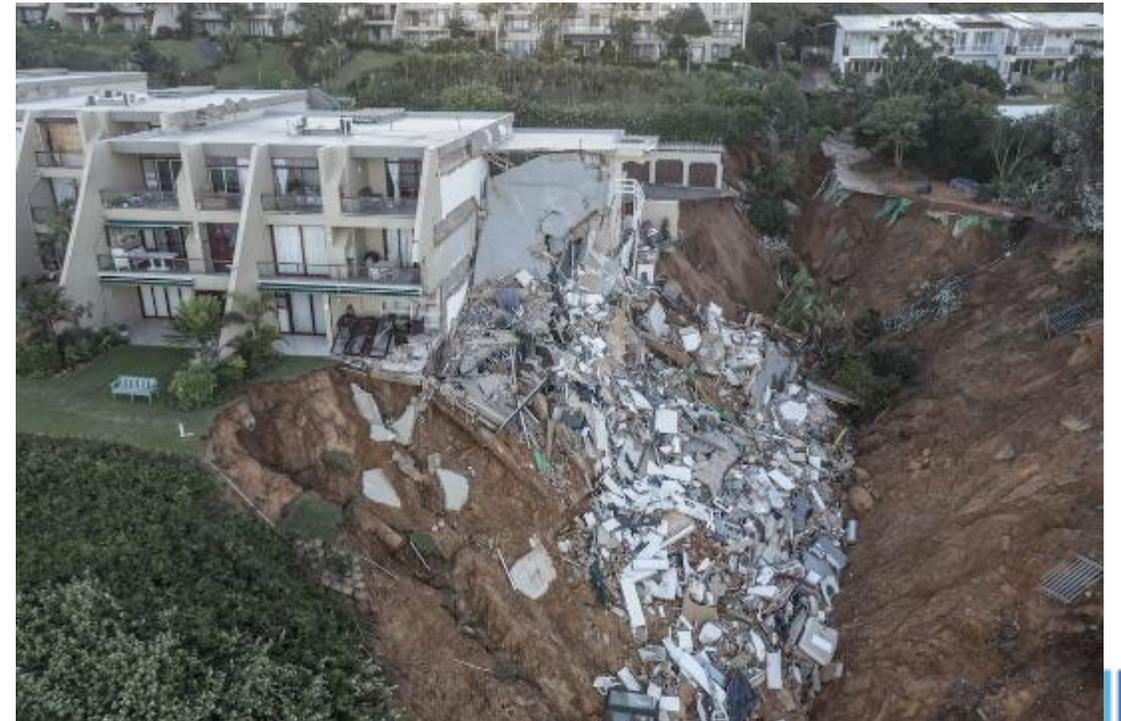
CAUSE OF WASHAWAY

- Steady rainfall in early April .
- Increased harden surfaces and removal of vegetation within the Umdloti catchment area.
- Large volumes of water concentrated at low points.
- The concentrated flow point along the dune sand created erosion channels.
- Dune sand is highly erodible.
- The erosion channels attracted more surface water thereby accelerating the erosion rate.
- Contributed to various washaways along the Umdloti Dunes.

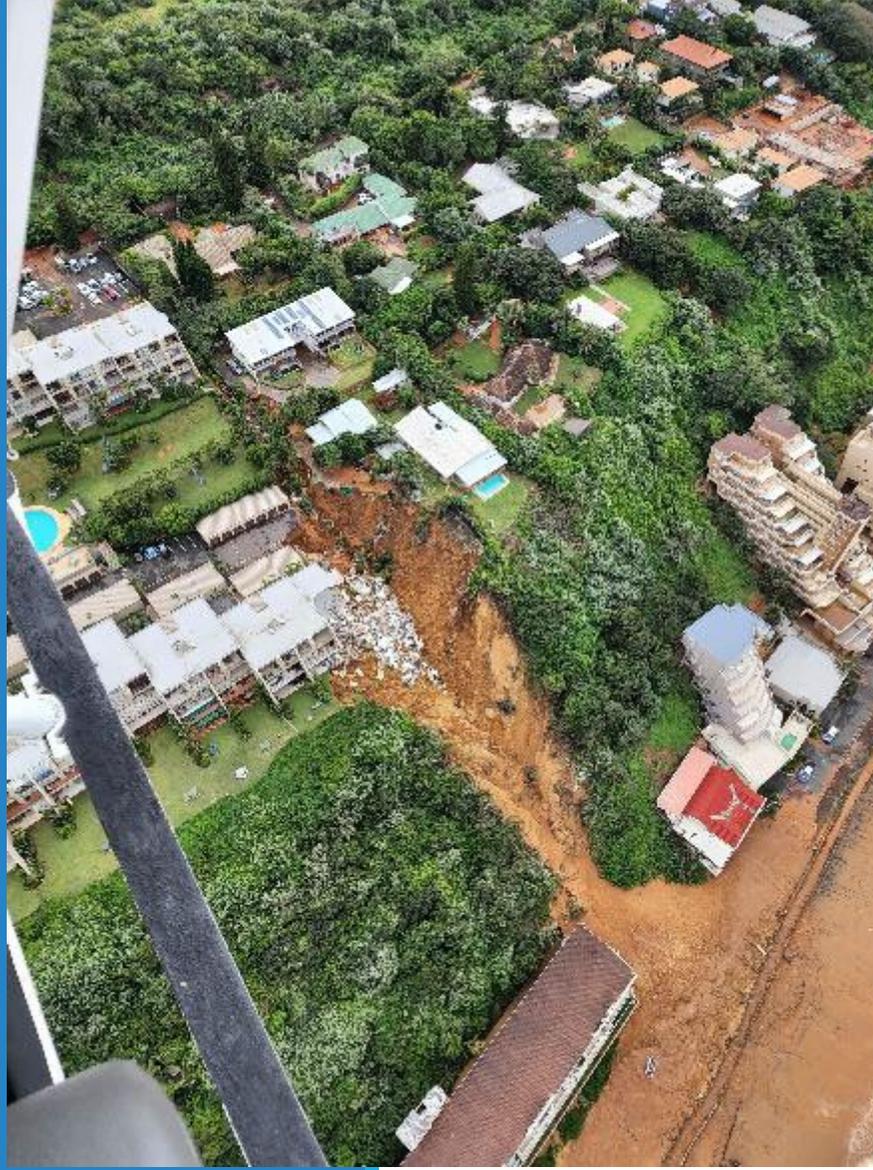
35/36 Bellamont Road

- Scour depth of greater than 50 m.
- 76 300m³ of material was washed away.

3D VIEW

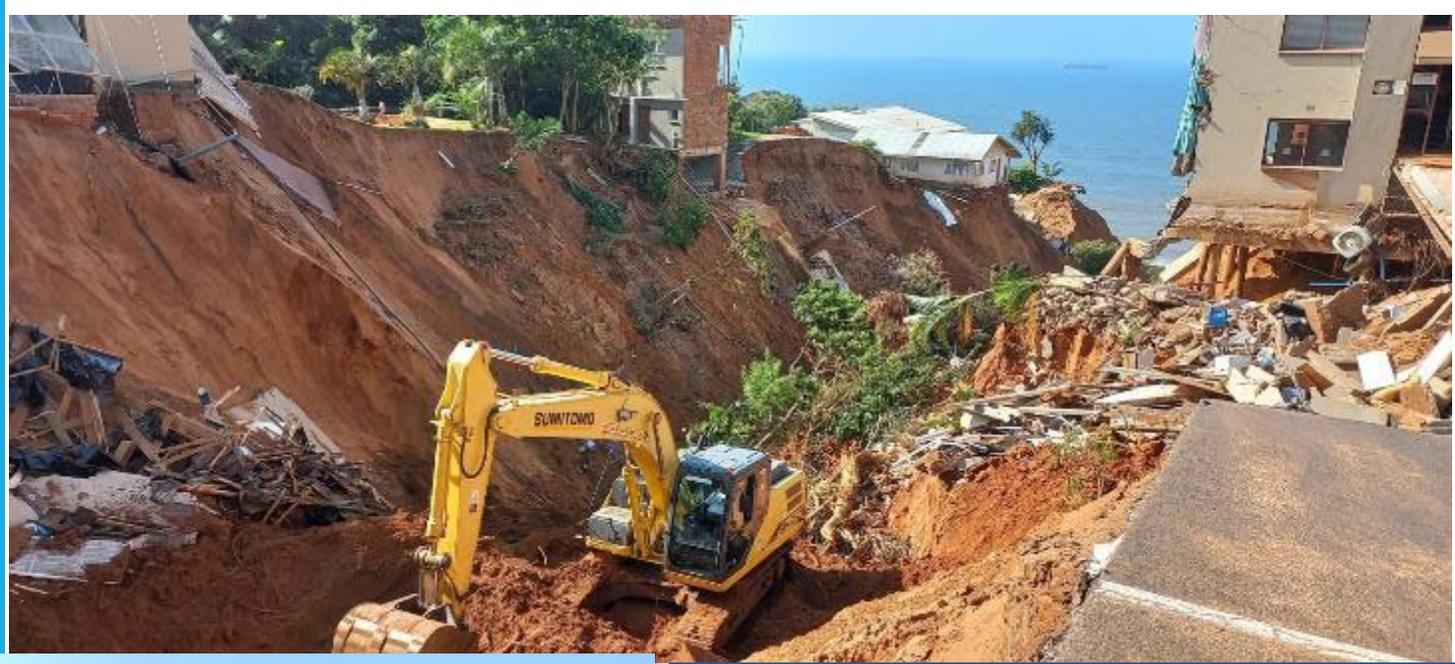
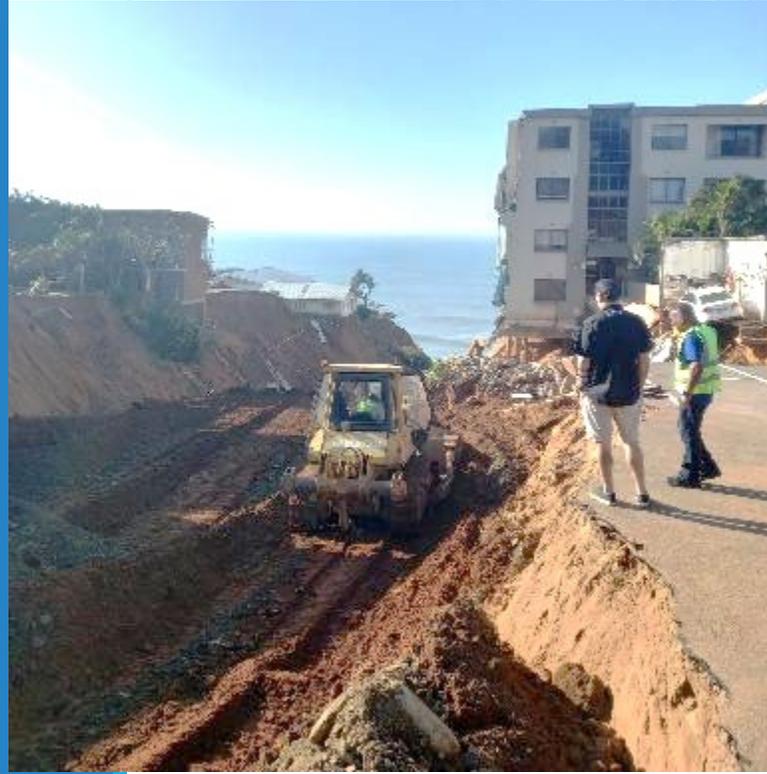
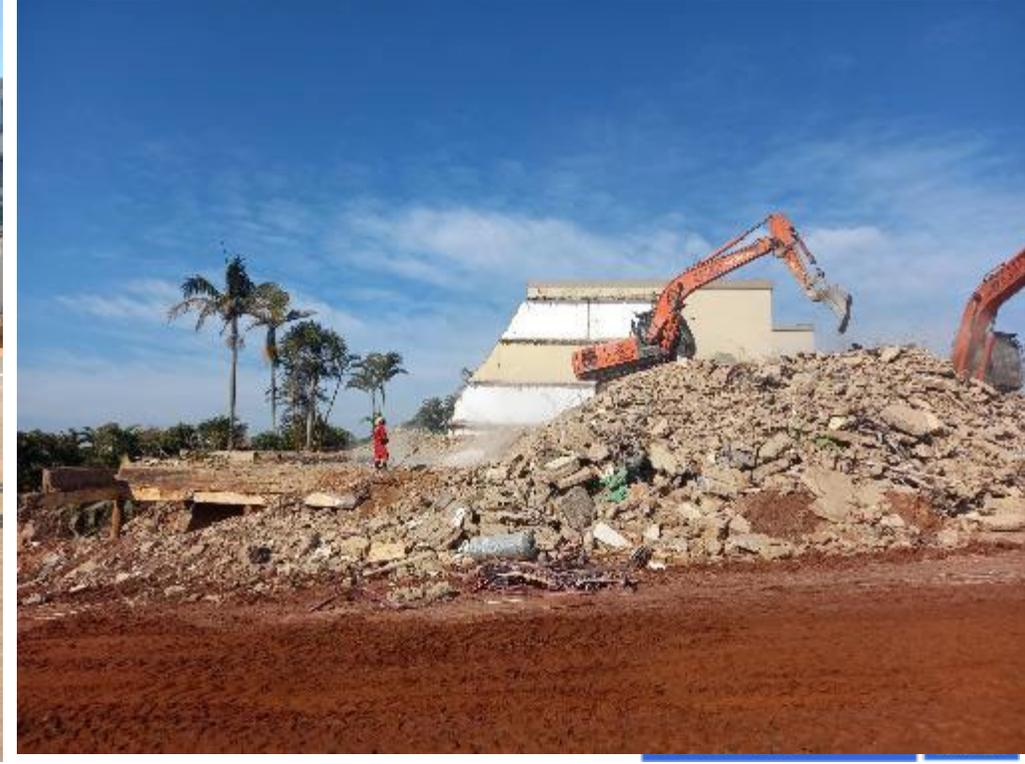
CONSTRUCTION RESTRICTION

- Health and safety analysis was critical due to the unstable nature of the site.
- Access was limited, material was end-tipped at the top of Bellamont Road and excavators were used to carry the fill material further down the scour.
- Surrounding building were unstable. Vibration had to be minimized. Until they were demolished.

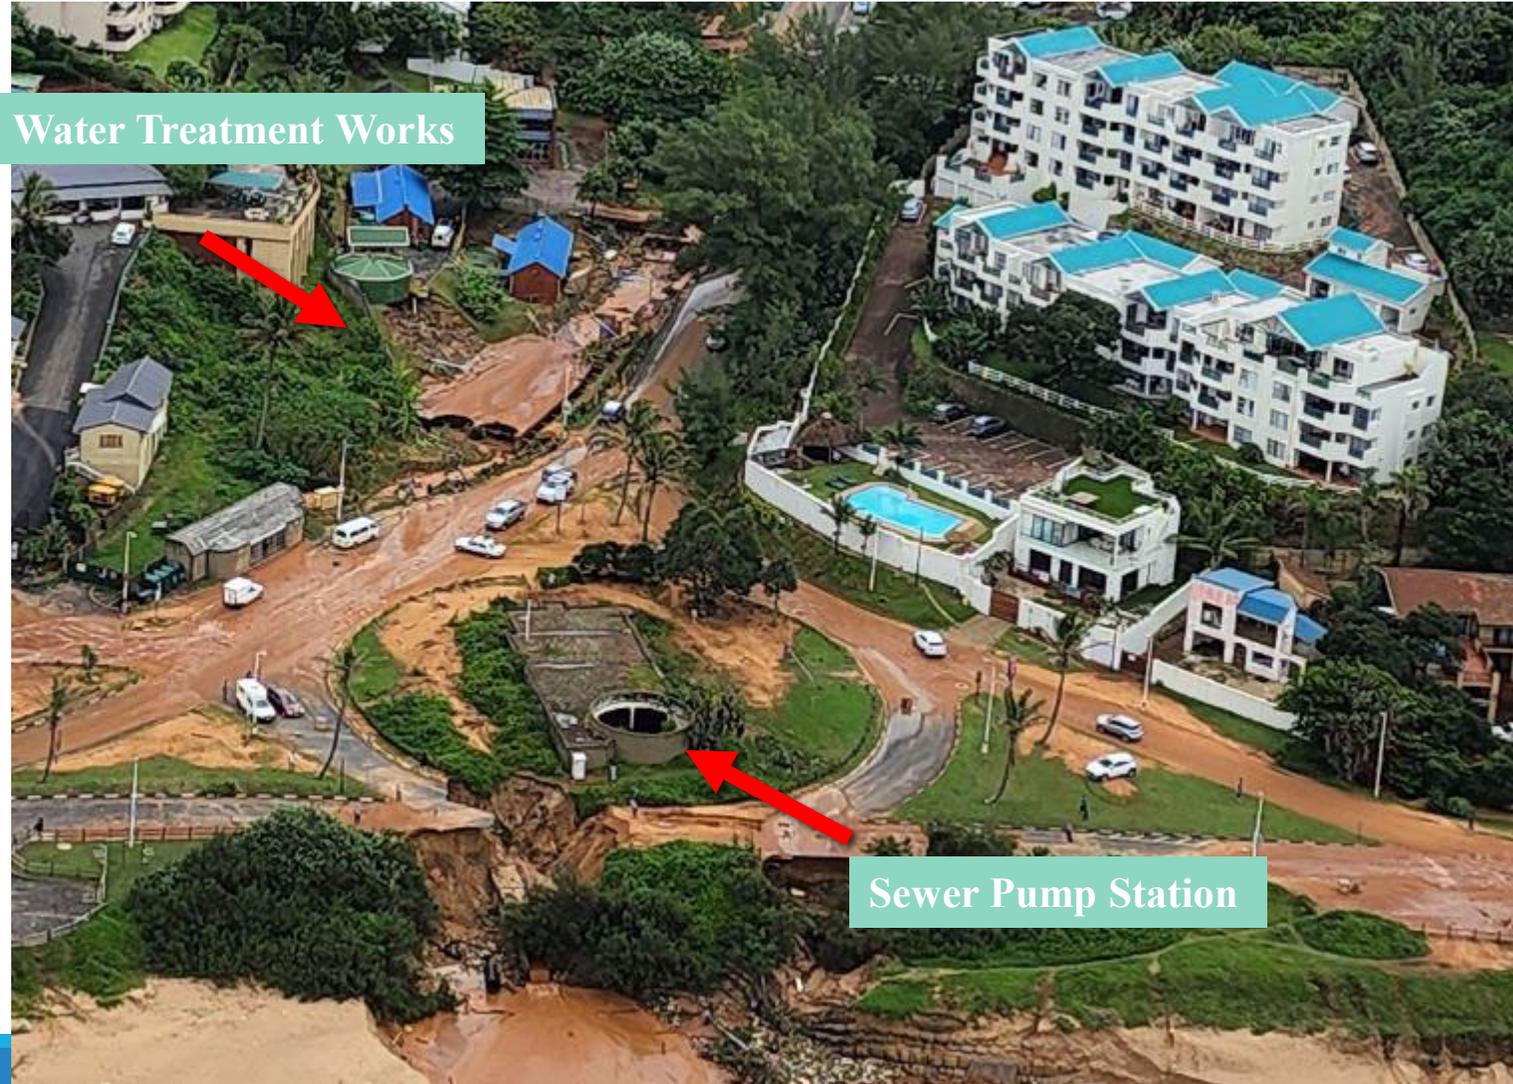
JABU NGCOBU DRIVE CULVERT

- Existing Culvert Overtopped.
- Only access road into Umdloti restricted.
- Water treatment infrastructure damaged.
- Flooding of Sewer Pump Station.

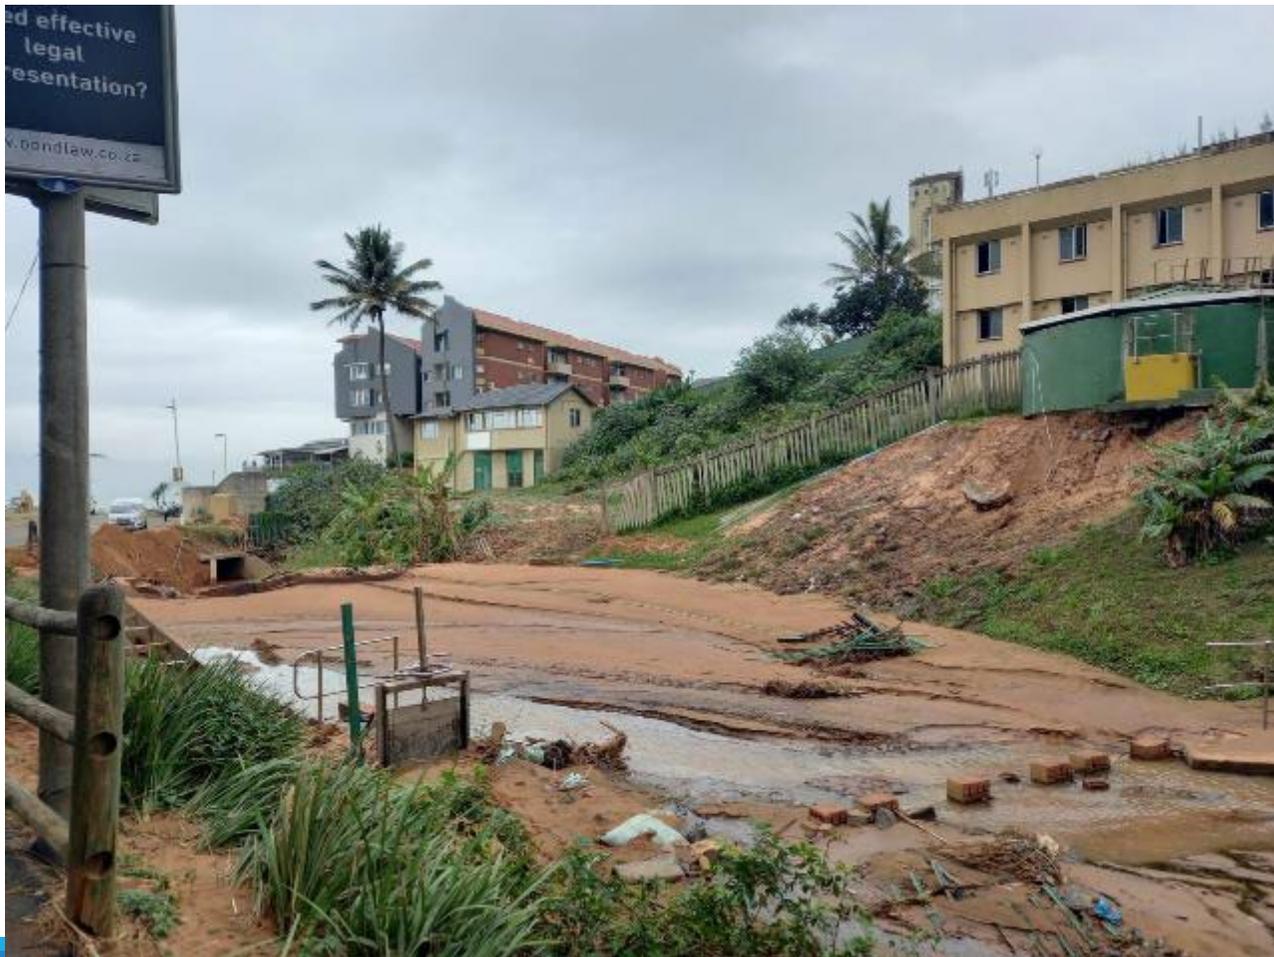
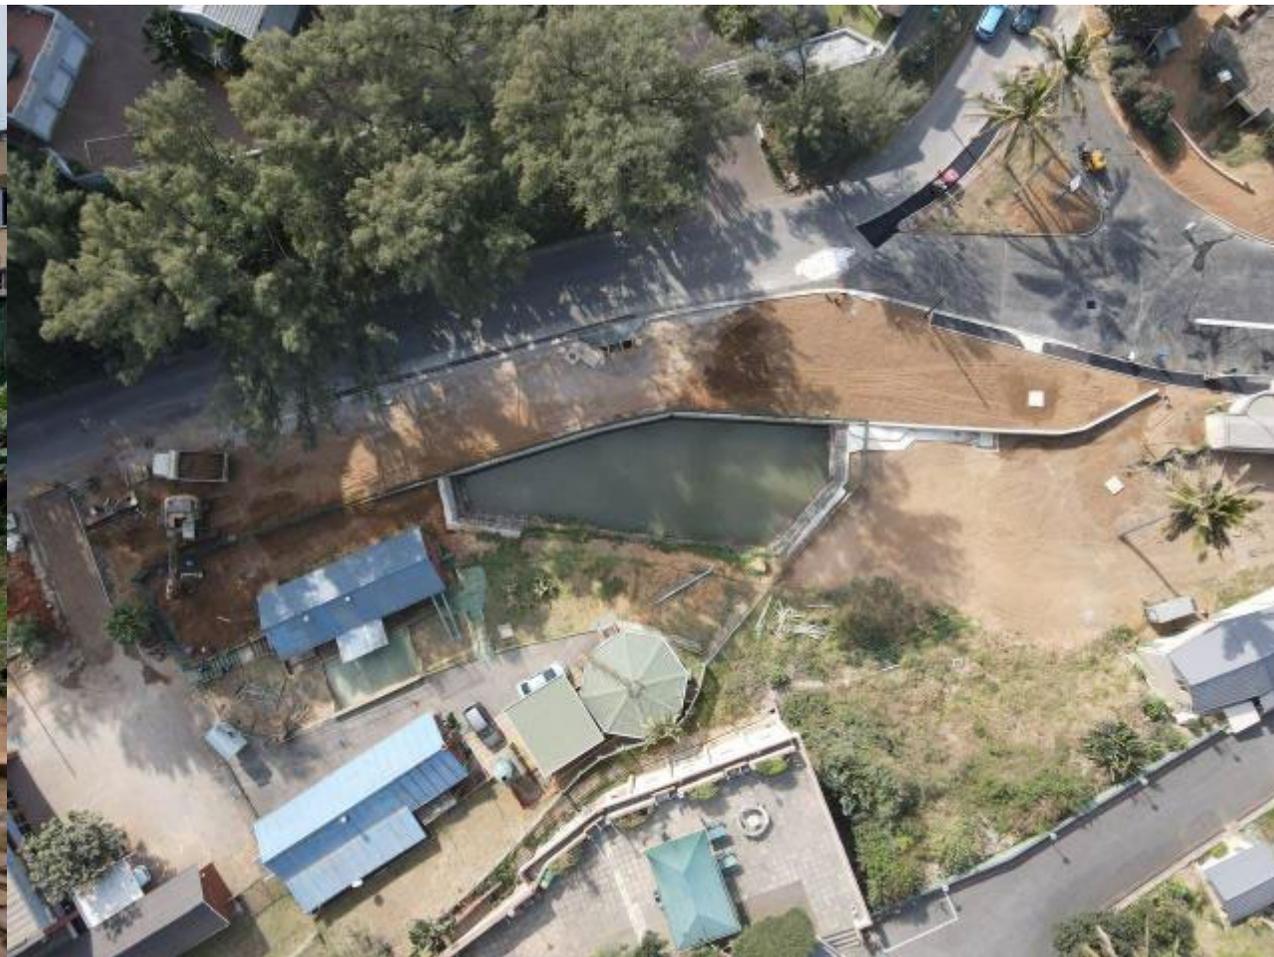
- Isolation and improvement of the Water Treatment Works.
 - Provision for present and future services.
-
