AUDITOR - GENERAL
SOUTH AFRICA

FIRST SPECIAL REPORT

on flood relief funds

31 August 2022

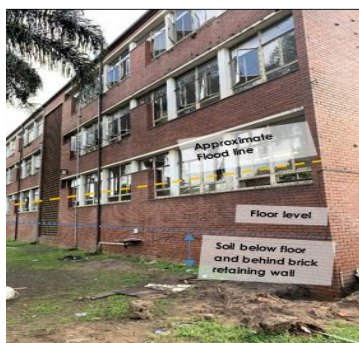
IMPACT: Despite the potential structural damage, learners used classrooms on the first and second floors, posing safety concerns. The classrooms were also overcrowded as learners on the ground floor were accommodated on the first and second floors after the flooding, affecting the quality of learning.

School classrooms structurally unsafe for use

We recommended that the structural damage should be addressed and that the needs assessment should be updated to ensure that the school is safe for use. The department responded that the Development Bank of Southern Africa had been appointed to undertake major repairs and renovation at the school to address the structural concerns. Attention is also being given in the interim to finding a solution for the flooding and a suitable placement for the units for learning to continue within a conducive environment.

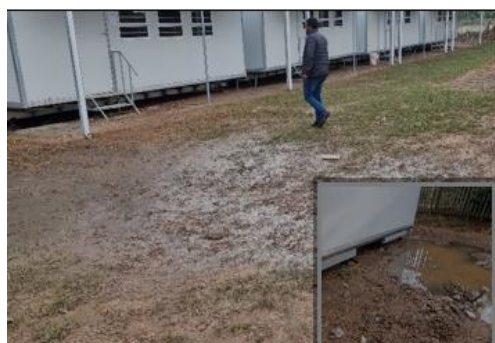
Mobile units constructed on land previously submerged by floods

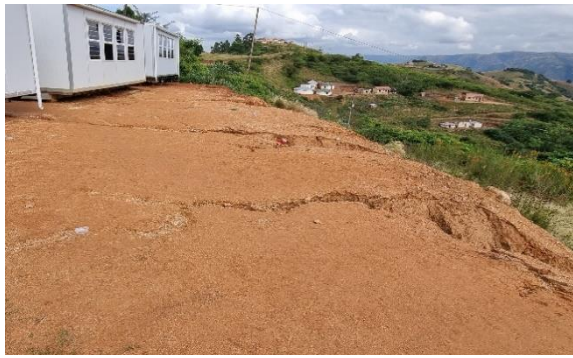
During our onsite inspections, we found that mobile units were poorly positioned. At Maphephetheni Secondary School, mobile units were located one to three metres away from an eroding embankment and stormwater was not channelled from the downpipes safely away from the embankment (which is a specification requirement). Embankments requiring a retaining solution were not included in the specifications despite it being necessary, which exposed the newly constructed units to flooding.

Poor drainage and erosion

We recommended and the department agreed that all projects should be inspected for adherence to specification requirements; outstanding certifications should be obtained (such as for the compacting of ground); and embankments should be reinforced and signed off as complete by the infrastructure unit before payments are made to reduce the risk of payments for goods that do not comply with the specifications and possible financial losses.

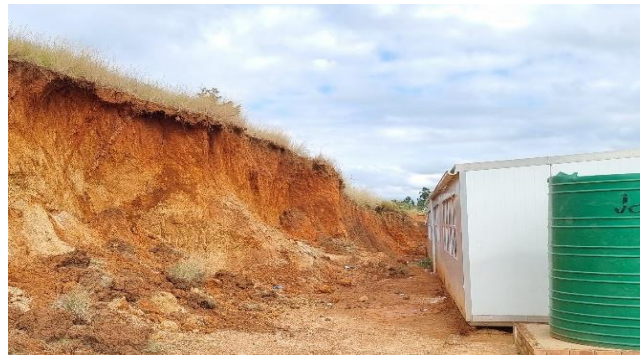
Placement close to steep embankment

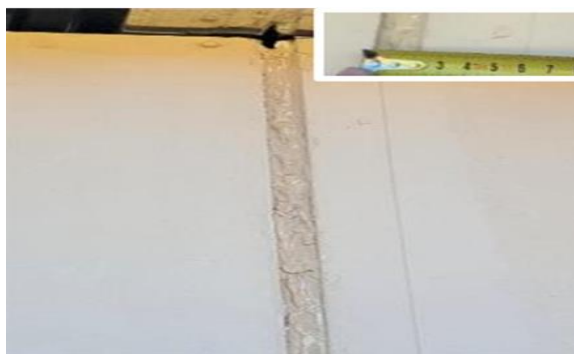
We also identified numerous quality defects, including wall panels incorrectly positioned and not aligned as well as water saturation of wall panels and inadequate waterproofing, as evidenced by holes in roof sheeting and gaps between wall panels and the roof.

Gap (2,5 cm) between wall panels filled with sealant

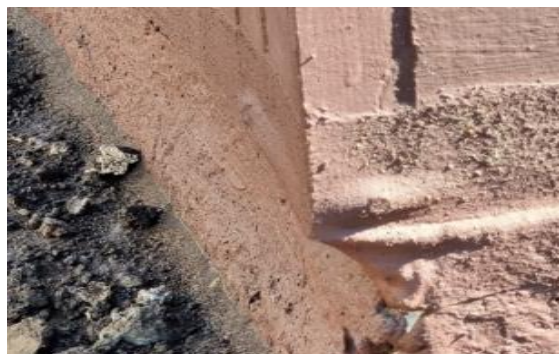
Wall panels positioned outside concrete slab's edge

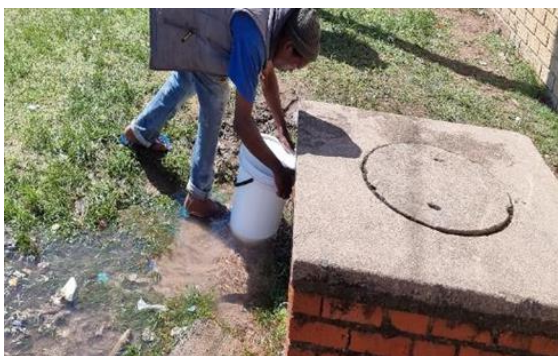
The ineffective utilisation of water tankers delayed efforts to supply communities with water for drinking and washing, causing some residents to resort to using unsafe water for their basic needs.

Overflowing manhole used as source of water in KwaDabeka
